Subject: Addendum
Evaluation of Potential Air, Water, and Soil Impacts from Sludge-Related
Operations at Rio Rico Sanitary Landfill (RRSL), Santa Cruz County, AZ

Addendum – Air, Water, and Soil Sampling for Sludge Application Impacts
Rio Rico Sanitary Landfill (RRSL)
1500 West Frontage Road
Rio Rico, Santa Cruz County, Arizona

Figure 1
Sample Location Map

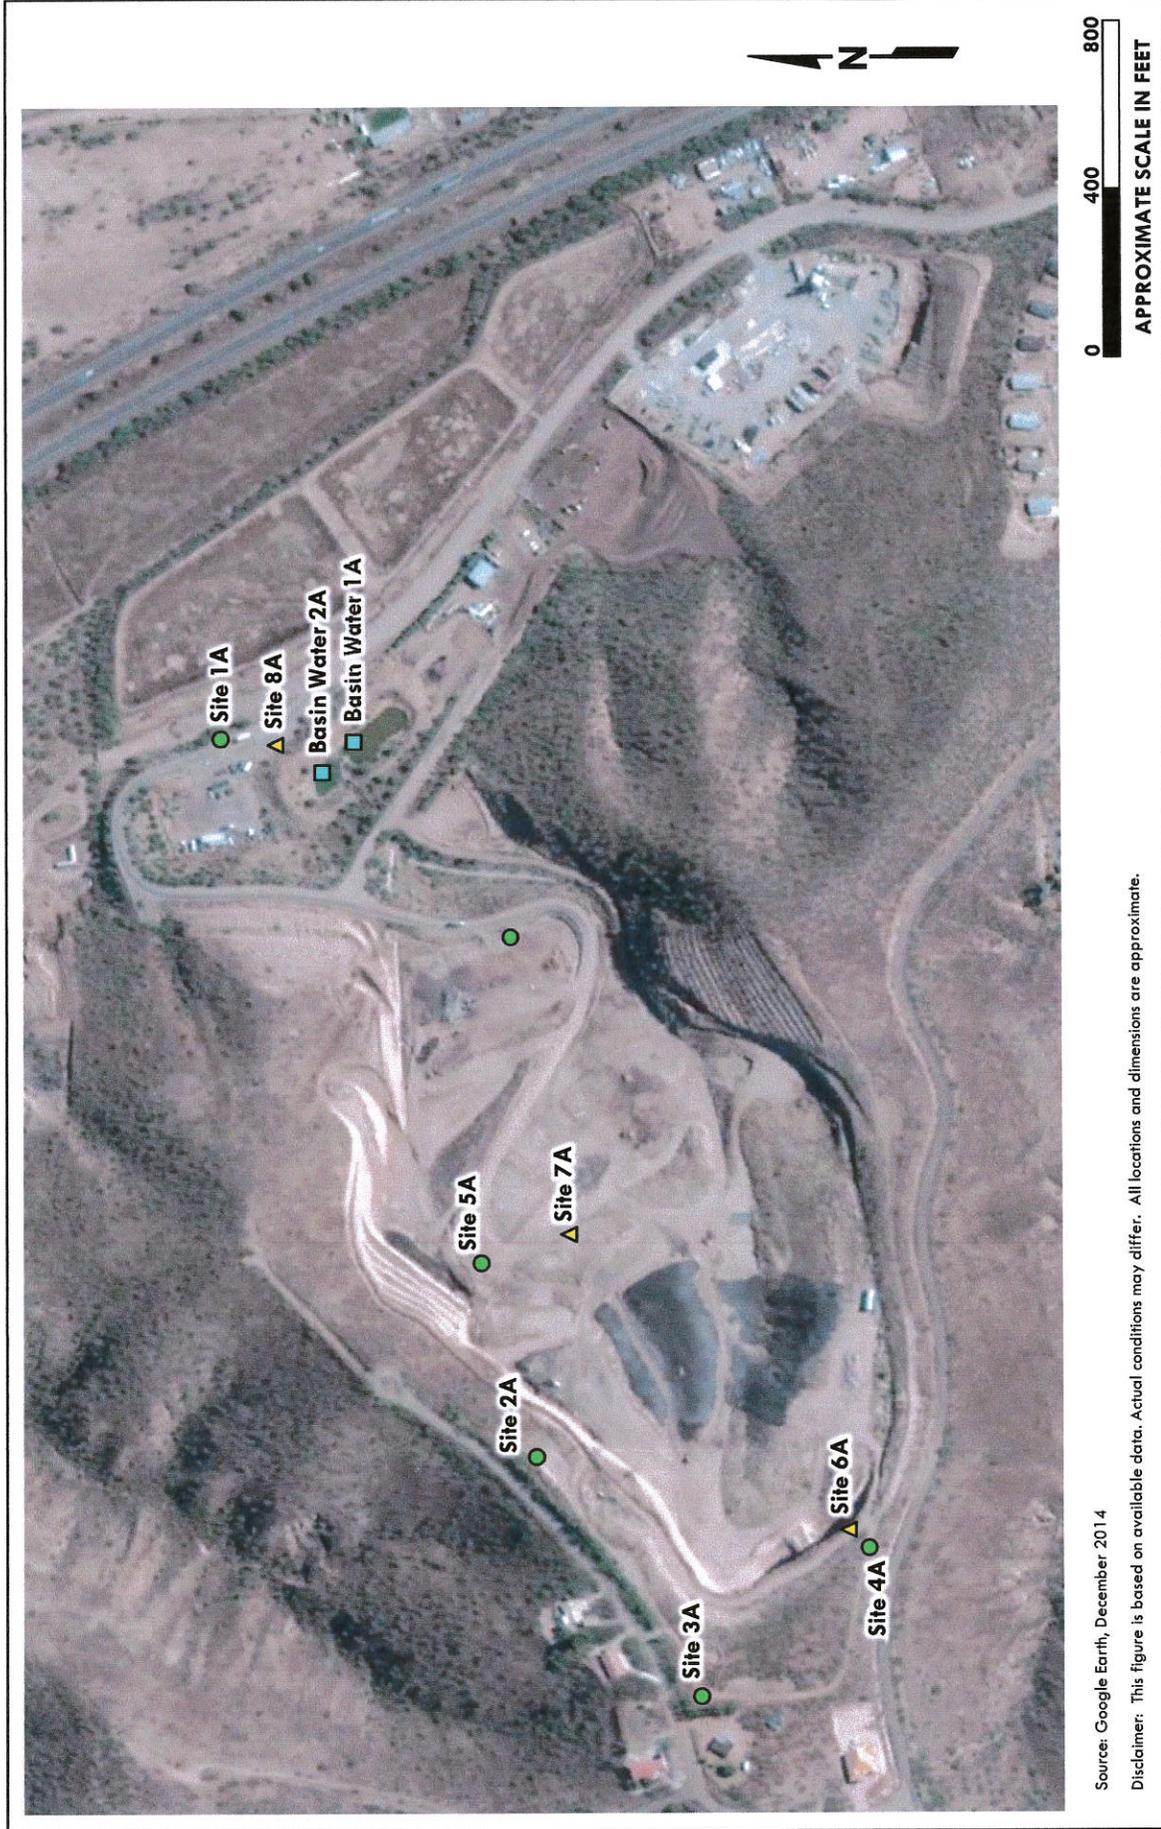
The RRSL stormwater retention basin is approximately 360 feet long and 150 feet wide and is located within the eastern portion of the site, as shown in Figure 1. Because stormwater runoff from the landfill is directed toward and stored in the basin, runoff from areas where sludge-

On April 22, 2015, SCS collected two grab samples of water (Basin Water #1A and Basin Water #2A) from the water's edge at the retention basin. Sample locations are shown on Figure 1. Both samples were placed into laboratory-supplied bottles and jars. Each container was labeled with the sample location, date and time of sampling, and name of the sampler.

On April 22, 2015, SCS collected samples from native soil at these three (3) locations (Sites 6A, 7A, and 8A). Each sample was collected from the ground surface directly into a laboratory-supplied 8-ounce glass sample jar that was then sealed with a Teflon-lined plastic lid. Each container was labeled with the sample location, date and time of sampling, and name of the sampler. Sample locations are shown on Figure 1.
